# Manhole Inspection Summary

Manhole # S04AA2019MH

Insp Date: **9/29/06 9:56 AM**

**Location** Address: **3601 CLARINTH RD**

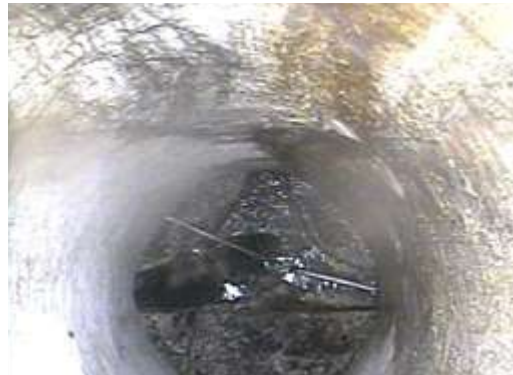
Top View

Adjustment, Corbel, and Barrel infiltration.  
Bench leaks. Channel debris.

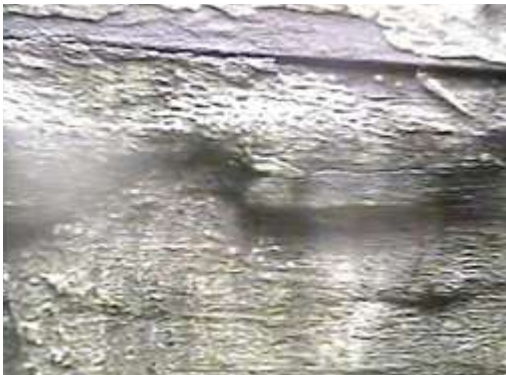
Defect

Adjustment infiltration.

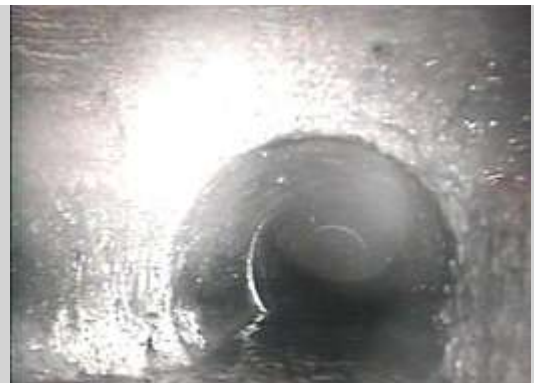
Pipe Out @ 12 O'Clock

Pipe Material: **Clay** ☐ Pipe Lined

Invert Depth: **10.34** (ft.) Flow Characteristics: **Slow**

Deposits: ☒ None ☐ Mud ☐ Sludge ☐ **Debris** ☐ Grease

Infiltration: **None** Pipe Seal Cond: **Unknown**

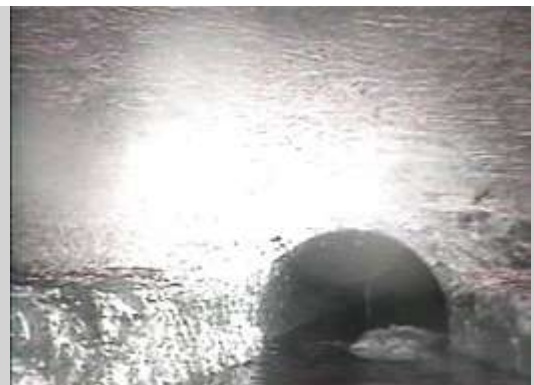
Pipe In @ 3 O'Clock

Pipe Material: **Clay** ☐ Pipe Lined

Invert Depth: **10.19** (ft.) Flow Characteristics: **Slow**

Deposits: ☒ None ☐ Mud ☐ Sludge ☐ **Debris** ☐ Grease

Infiltration: **None** Pipe Seal Cond: **Unknown**

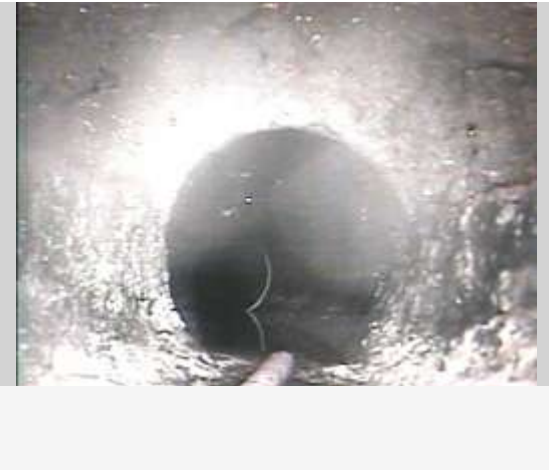
Pipe In @ 9 O'Clock

Invert Depth: **10.16** (ft.) Flow Characteristics: **Slow**

Deposits: ☐ None ☐ Mud ☐ Sludge ☒ **Debris** ☐ Grease

Silt Depth: **1** (in.)

Deposits Extent: **Light**
